## The Use of Living Shorelines to Mitigate the Effects of Storm Events on Dauphin Island, Alabama, USA

Dauphin Island, Alabama. The purpose of this paper is to describe the planning process, installation, and short-term results of a living shoreline project using concrete wave attenuators for erosion control and habitat creation.

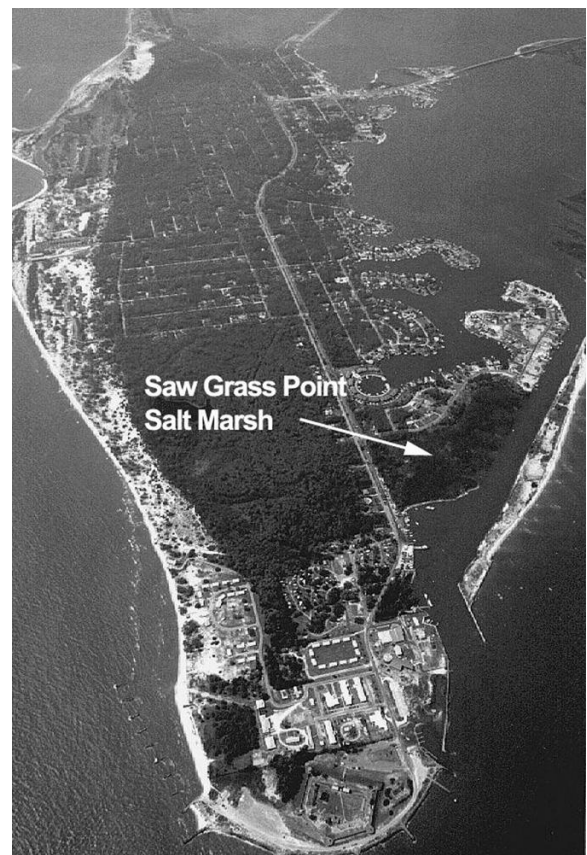
Figure 2. Photograph of the east end of Dauphin Island with Saw Grass Point Salt Marsh identified.

Saw Grass Point Salt Marsh is the largest marsh on the east end of Dauphin Island (Figure 2). This 14.1-ha saline tidal marsh with its three tidal creeks is of significant ecological importance and has been identified as an area in need of protection (DIBBS 2003). The predominate marsh species are black needlerush *Juncus roemerianus* and fringing cordgrass *Spartina* sp. communities. Approximately 3 ha from Saw Grass Point Salt Marsh was destroyed in the 1950s when it was dredged to create Fort Gaines Harbor on the east end of the

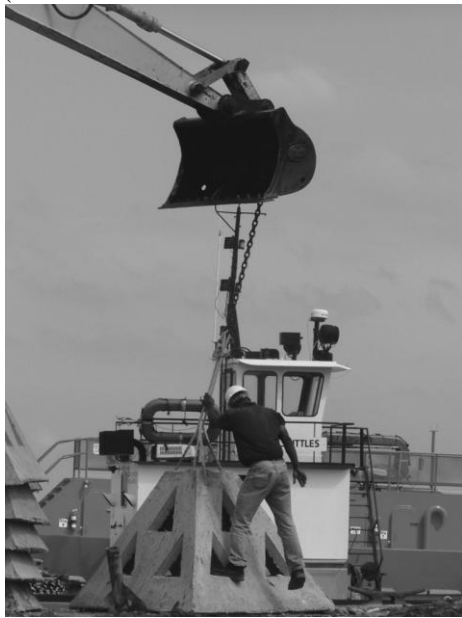
*Figure 3. Photograph of coastal havens used at Saw Grass Point Salt Marsh on Dauphin Island, Alabama.*

Each of the coastal havens units has a base length of approximately 2.4 m and a height of approximately 1.7 m. The average volume of individual units is 1.2 m<sup>3</sup> and each weighs 1 metric tons (mt). The units do not require anchoring and, therefore, can be positioned or repositioned as necessary. To release wave pressure buildup (USACE 1985), each unit has three 40 cm/side triangular openings per side and a 27-cm-diameter circular opening at the top of the hollow unit (Figure 3). The cost is approximately \$400 per unit.

1985). Surgebreakers and coastal havens are made from precast marine concrete, are pyramidal, and have pressure release openings. However, the dimensions and configuration of the pressure release openings are different between the two structures and surgebreakers are deployed side by side in a single row while coastal havens are placed side by side in an offsetting double row.

The nonsegmented placement of the coastal havens in two staggered parallel rows allows them to function as an exposed and detached breakwater to minimize erosion along the eastern shore of the marsh. The coastal havens are designed to decrease the water velocity by reflecting, refracting, and diffracting much of the wave energy vertically and horizontally along, around, and through the pyramids before the waves reach the shore (French 2001; Reeve et al. 2004). Studies conducted by the U.S. Army Corps of Engineers, State of Maryland, and Commonwealth of Virginia (1990) determined that the effects on local wave and sediment transport (functional design) were largely influenced by the ability of the structures surviving a storm environment (structural design). The mass of the coastal haven units and the pressure release opening are important in meeting their structural and functional design of attenuating potentially damaging waves.

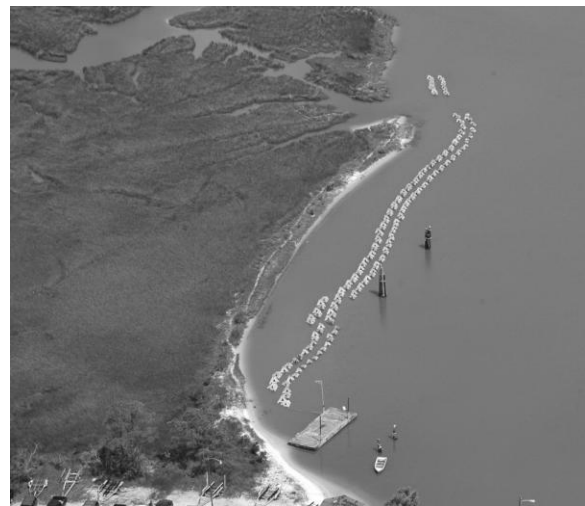
*Figure 4. Aerial photograph of Saw Grass Point Salt Marsh, Pass Drury Channel, Fort Gaines Harbor, and the 182 coastal havens after they were installed. A visible gap between the long and short segments can be seen in front of one of the three tidal creeks within the marsh.*

On 5–6 April 2005, 182 units were placed in two rows along 162 m of the eastern perimeter of the marsh (Figure 4). The units were transported approximately 120 km by barge through the Intercoastal Waterway from Pensacola, Florida. A nonsegmented design for breakwater placement was chosen over a segmented design to minimize the likelihood of parabolic bay-shaped salients or tombolos, which commonly form behind a segmented design (Birben et al. 2006). Individual units were arranged in two parallel interlocking rows (centroid location of N 30° 15.145' W 088° 04.914').

There was a 10-m gap between two sections of breakwater units near the northern end of the installation to minimize disruptions in flow of a nearby tidal creek. Units were placed approximately 9 m offshore from the centerline of the marsh berm in water

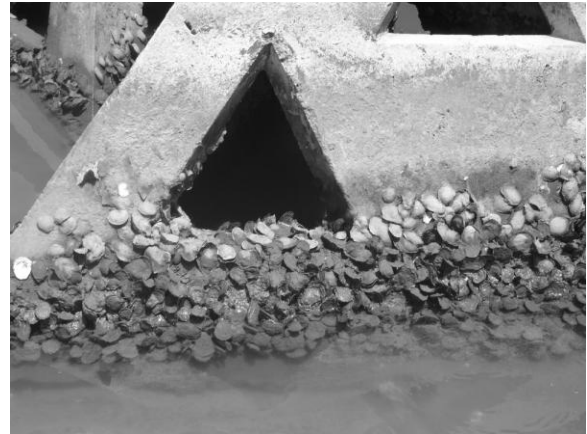
Figure 5. Photograph of coastal havens with oysters visible on the lower one-third of each unit. Mean oyster density in November 2006 was 205 oysters/m<sup>2</sup>.

The coastal haven units provided excellent hard substrate on which oysters have established. These created oyster reefs may provide various ecosystem services, including improvement of water quality (Newell and Koch 2004) and creation of a foraging area for fish (U.S. Army Corps of Engineers, State of Maryland, and Commonwealth of Virginia 1990). In November 2006, a random sample of oyster density on individual units was 205 oysters/m<sup>2</sup> (Figure 5) compared to 150 oysters/m<sup>2</sup> on Alabama's most productive oyster reef located approximately 4 km north at Cedar Point (Alabama Department of Conservation and Natural Resources, Marine Resources Division, personal communication). The high oyster density is likely a result of the vertical relief provided by the units and due to the fact that oysters set equally well on the inside surface of the open structures as on the outside surface. Colonization of the units by oysters increases the total volume of the breakwater resulting in additional wave attenuation. Other ecosystem services provided by the breakwater include refuge habitat for aquatic animals and the use of the exposed portions of the breakwaters by colonial seabirds (Yozzo et al. 2003). The foraging and refuge habitats are essential for locally important species such as: spotted seatrout (also known as speckled trout) *Cynoscion nebulosus*, blue crabs *Callinectes sapidus* and Gulf stone crabs *Menippe adina*, eastern oyster *Crassostrea virginica*, red drum *Sciaenops ocellatus*, southern flounder *Paralichthys lethostigma*, and various species of commercially important shrimp (brown shrimp *Farfantepenaeus aztecus*,
